UNIQUE SOLUTIONS

Helping Chemical Company Maintain ISO 14001 Certification

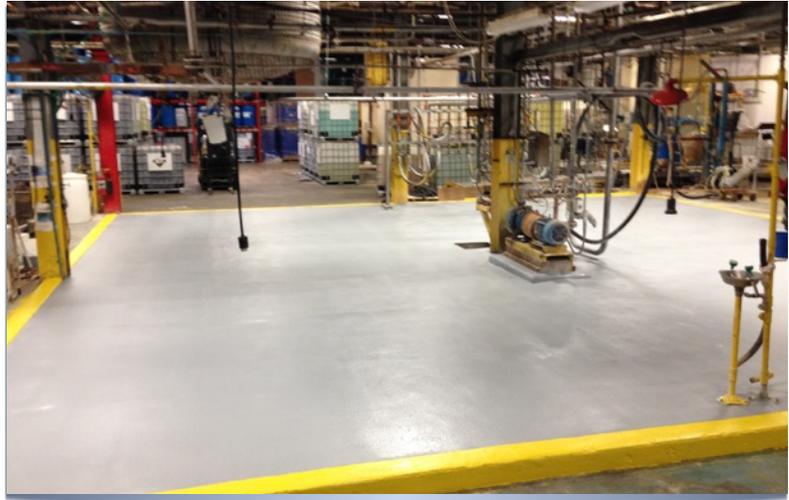
CPI Industrial's highly chemical resistant and abrasion resistant broadcast laminate system was specified specifically for the wide array of chemicals being produced in this area and the physical abuse from the day to day operations. The Aluminum broadcast aggregate was chosen over standard silicas to help handle the heavier than normal impact and abrasion the floors were being subjected to daily.

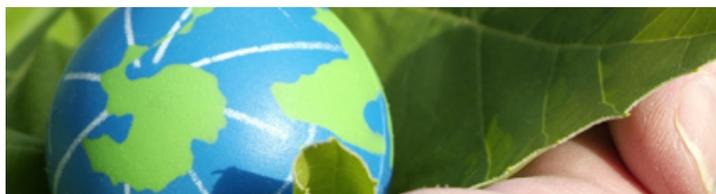
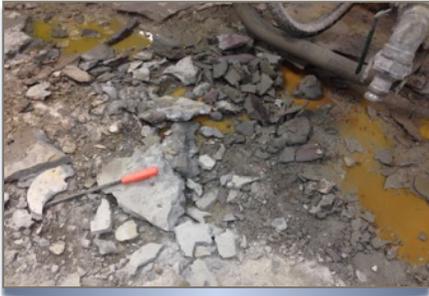
Chemical & Physical Attack!

The chemicals being produced in this facility along with the day to day operations were destroying the concrete and eating through the original coating system applied to help protect it.

CPI's experience and invested commitment to preparation was invaluable in a project like this. The damaged concrete and old coatings had to be removed to help ensure a good substrate for the new flooring system to bond to. This will help the new flooring system provide years of service.

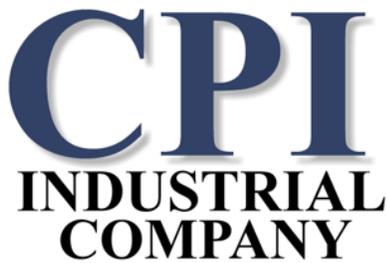
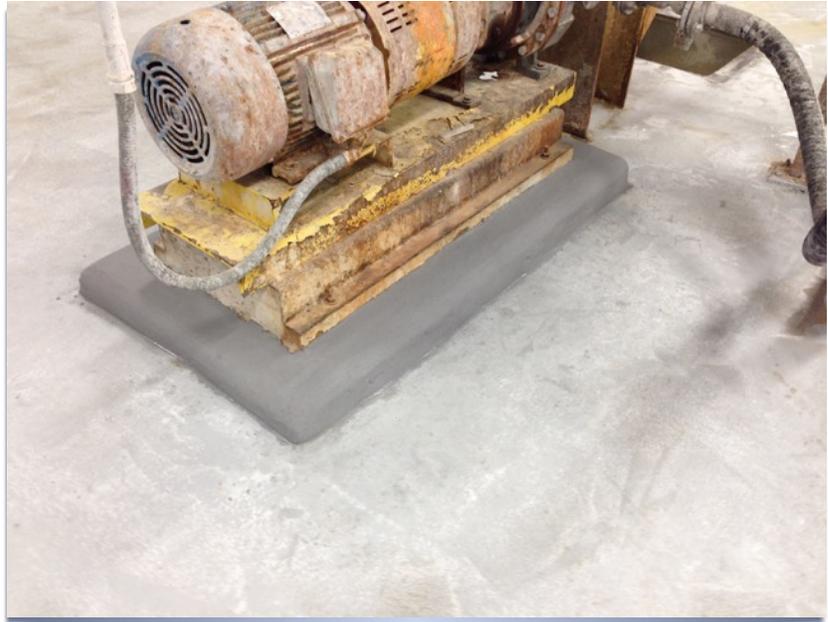
CPI Industrial rebuilt the pump pad and the inside of the sump.

CPI Industrial also made sure that the floor continued to slope to the sump pit prior to the application of the chemical and abrasion resistant laminate system.
