# UNIQUE SOLUTIONS

CPI Industrial helps Cargill facility adhere to FDA regulations

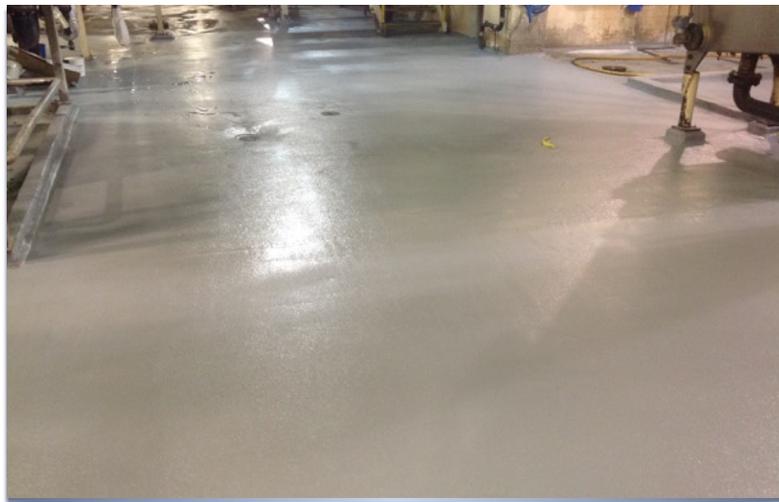
CPI Industrials 1/4" Urethane mortar slurry was chosen because of its ability to handle the thermal shock of the hot oil and daily sanitation process. There new seamless system was also resistant to the chemicals used in the same sanitation process. The new non-slip finish also made it safe under foot for the employees.

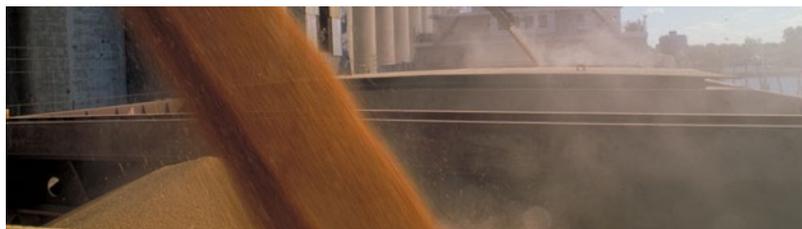
Due to their daily sanitation process, Cargill exposes their flooring surfaces to extreme thermal shock. With food Safety being a top priority, a seamless system is needed to help ease the sanitation process and make it hard for bacteria to grow and multiply.

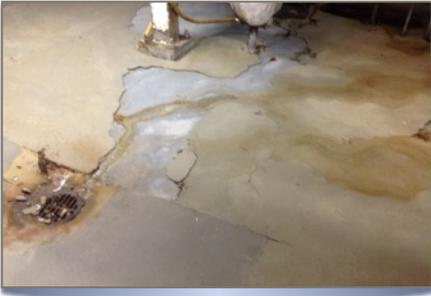
### Thermal Shock Damage

The thermal shock from the actual plant processes as well as the sanitation process can be very destructive on a coatings or lining system that is not designed to handle that kind of abuse.

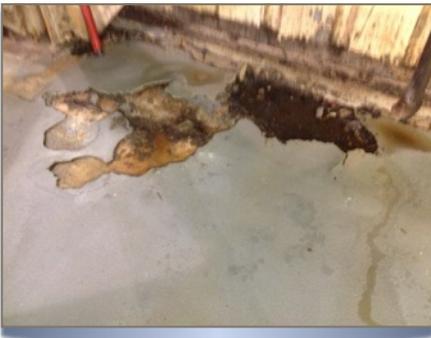
Poor preparation and bond of previous coating systems were also visible throughout the facility. CPI Industrials preparation included the removal of these loose and failing coatings down to the concrete to insure the bond of the new urethane mortar application.
